## CASE STUDY

Surveying the Hayla Tower, Liwa Oasis, Abu Dhabi, UAE.

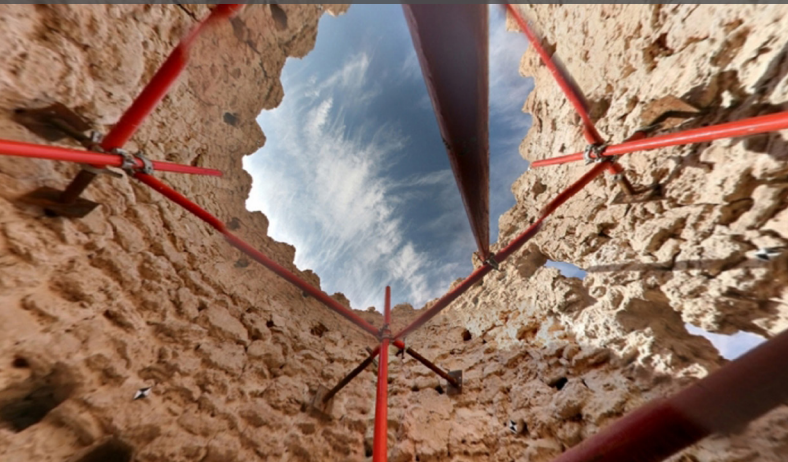
The tower heavily braced interior:

Due to the existence of scaffolding covering the entire structure externally and internally, the site lent itself in the favour of laser scanning as the likelihood of scaffolding obscuring end deliverables was eliminated by multiple scan cloud coverage. Internally, with such limited fields of view, difficult access and mass of scaffolding covering lines of sight, photogrammetric results would have been severely compromised, whilst the use of a centrally located 360° rotating laser scanner was well suited to this challenging environment.

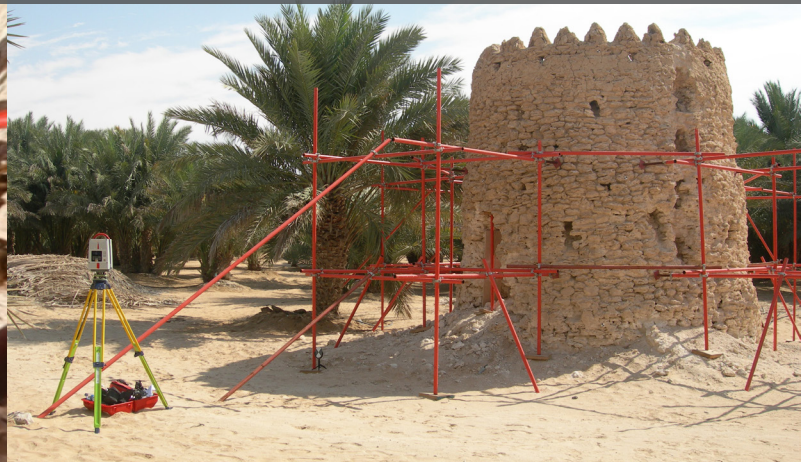
The Hayla Tower and its date palm, Oasis setting.
